NAME OF VESSEL: NETTIE **HAILING PORT:** NY9420 GK **SURVEY:** 10/10/23
H.I.N.: CUSTOM BUILT WOODEN VESSEL **OFF#:** NY 9420 GK
YEAR/BUILDER: 1997 FRENCH AND WEBB **MODEL:** FENWICK WILLIAMS 24' DOUBLE ENDER
OUR FILE#: IND CONS 23059 -CT **POLICY#:** NOT ADVISED
REPL.COST: \$420,000.00 **F.M.V.:** \$ 65,000.00

REQUESTED BY: Capt. Kfoury
DATE OF REQUEST: 10/1/23
LOCATION OF VESSEL: New Hamburg , NY.
TYPE OF SURVEY: Condition and Valuation for possible donation
USE OF VESSEL: Pleasure
NAVIGATIONAL LIMITS: Coastal
HAULED: No : Vessel afloat at time of inspection.

THIS IS TO CERTIFY THAT the undersigned surveyor James M. Dias, C.M.S., did attend Static Condition and Valuation survey to the above captioned vessel.

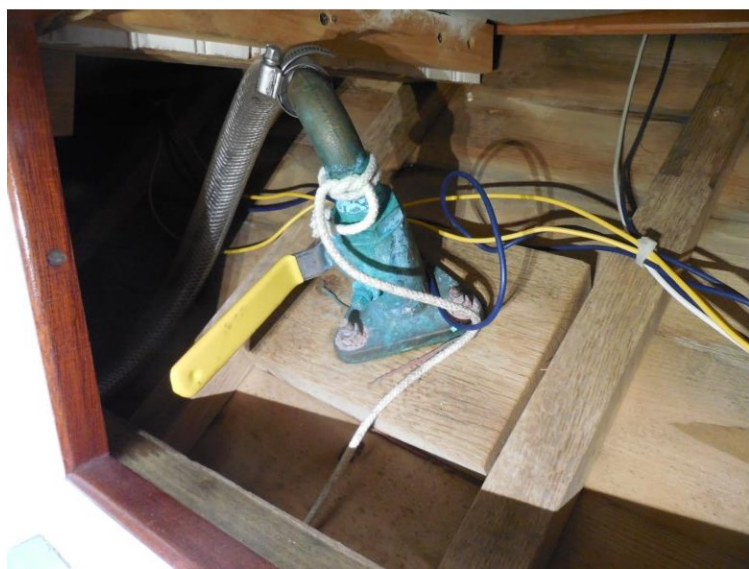
HULL CONSTRUCTION: Carvel Planked wooden vessel

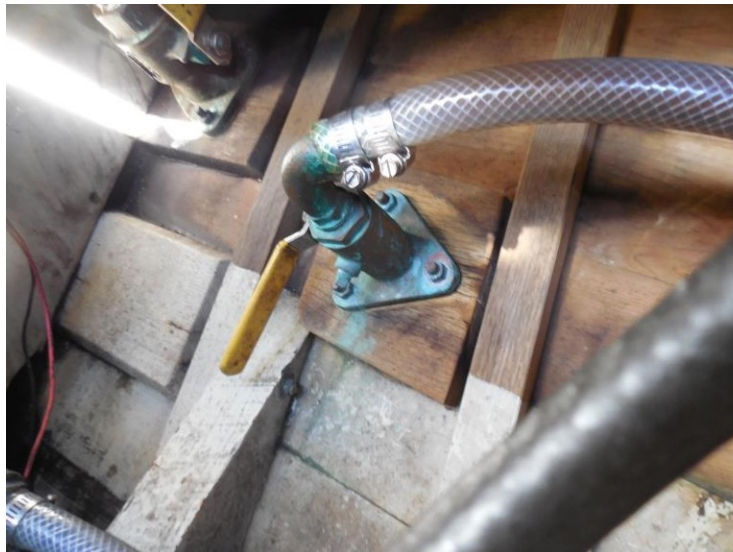
Close inspection of underwater through hull penetrations and hardware such as depth sounders and underwater gear through bolting was also made to determine attachment to hull and bedding .

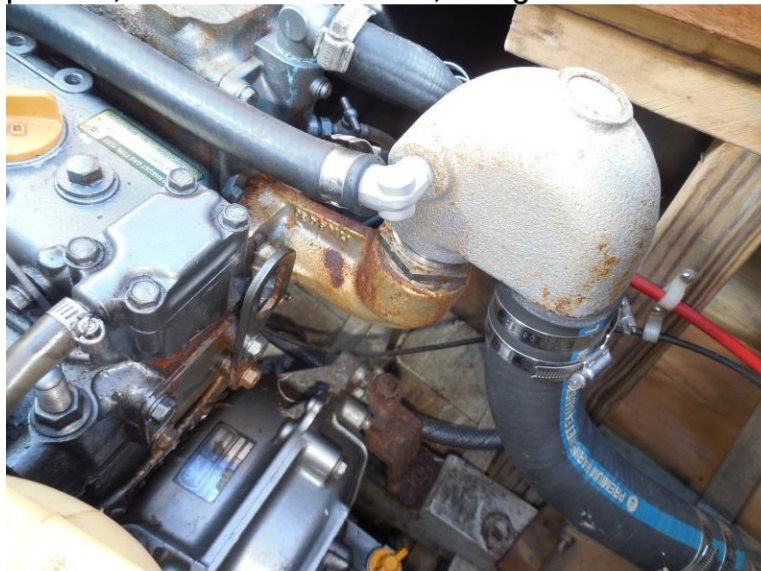
COMMENT: The engine was not run during survey. I recommend that the engine be run under load and proven, Fluid levels monitored, and general care exercised
